VIRGINIA FLIGHT SCHOOL SAFETY ARTICLE – NO 06/09

AIRFRAME STRUCTURAL INTEGRITY

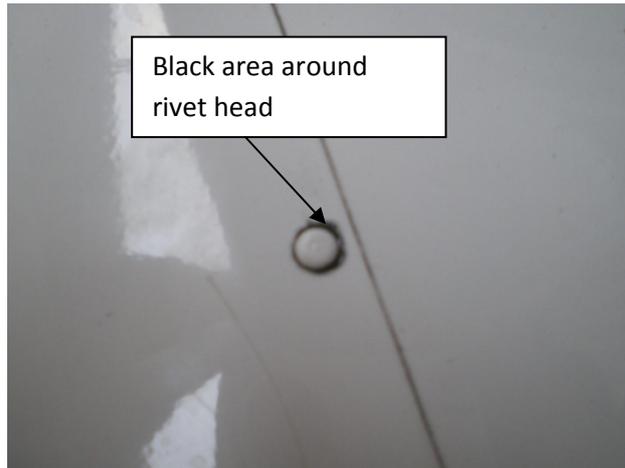
A “working” rivet is one that is no longer tight and secure and is identified by a dark area around the rivet head where the paint has been removed. The photograph on the following page depicts a working rivet.
